Broken Brooks

Repairing Past Wrongs

A Clean Annapolis River Project Initiative
By Katie Taylor, Ecological Restoration Technician
December 2010

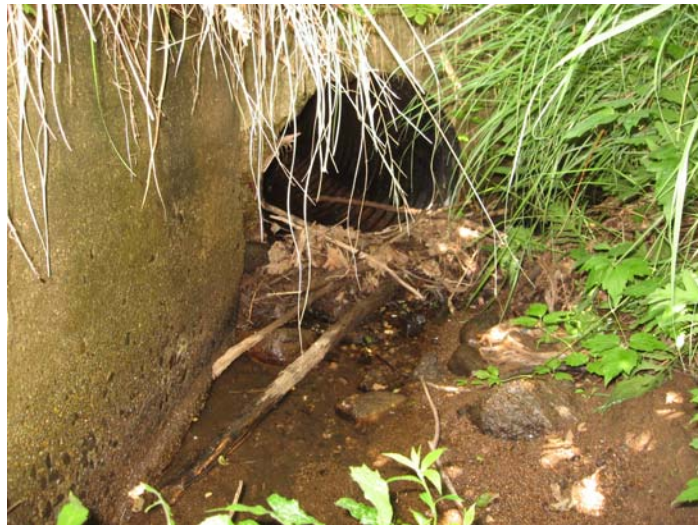
Allains River runs into the Annapolis Basin, the outflow runs along Fort Anne National Historic Site in Annapolis Royal. The river system is over ten kilometres long with multiple stream branches, anywhere from 400 to 1,600 metres in length. Allains River intersects six roadways: Route 8, Highway 101, Highway 1, Dugway Road, Clementsvalle Road, and West Dalhousie Road. There also exist two bridges and at least 14 culverts. All 14 culverts located on Allains River were assessed and four were deemed barriers to fish passage; one high priority culvert and three medium priority culverts. ALL022 that intersects West Dalhousie Road was determined to be a medium priority culvert (Figure 4). There are two steel culverts encompassed in a cement wingwall. Branches, leaves and sand had built up in front of the first culvert, which in turn is also obstructing fish passage to the second culvert (Figure 5). The debris was removed using a shovel, and placed further in on the bank so as not to wash back into the stream. With the debris cleared, water is now flowing freely through both culverts and over 650m of upstream habitat was gained (Figure 6).

Figure 5: ALL022 Inflow of culvert #1 pre-restoration

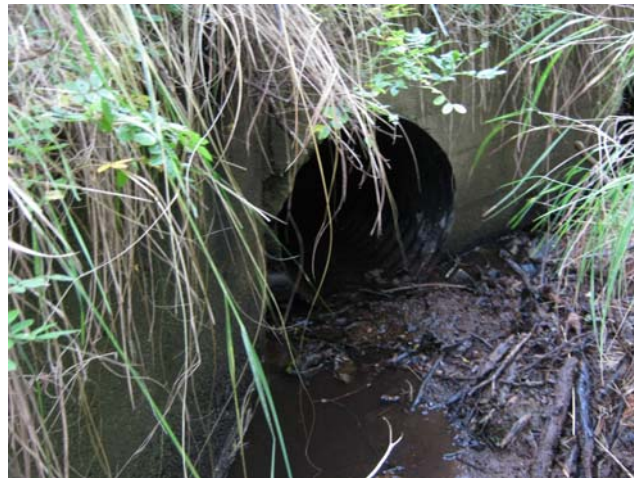
Figure 6: ALL022 Inflow of culvert #1 post-restoration

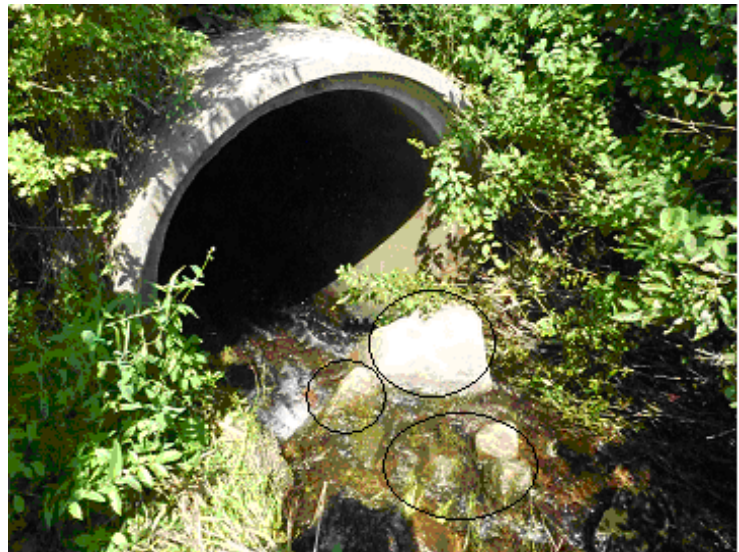
BLO011 is located on an unnamed stream, which is in the vicinity of Bloody Creek Brook. This un-named brook is just over three kilometres in length. Four roads intersect the brook: the old rail bed, Brickyard Road, Highway 201 and Highway 101. There are four culverts located on this brook; BLO011, which is located on Highway 101, is a high priority culvert and the only barrier culvert on this stream. A combination of rocks from the headwall, and rocks that have been carried downstream, have collected at the inflow side of the culvert causing a barrier to fish passage (Figure 7). It is hard to see from the image below, but the rocks located in front of the culvert are creating a drop as the water falls into the culvert. For a fish swimming up the culvert, it would be difficult to make the jump over the rocks and into the upstream due to the velocity of the upstream water and the lack of a pool at the base of the fallen rocks (Figure 8).

Figure 8: BLO011 Inflow highlighting barrier rocks

The objective for this culvert was to remove some of the barrier rocks and re-arrange them in the streambed, allowing for fish passage. The only equipment needed for this restoration was work gloves and steel-toed boots. The first step was to remove all of the barrier rocks. Next, the rocks were placed in the stream, creating a pool behind the large rock (Figure 9). This pool is to provide the fish a place

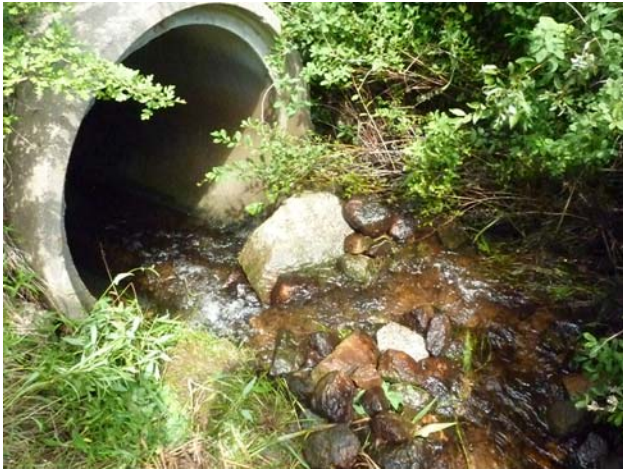
Figure 9: BLO011 Inflow post-restoration (a)

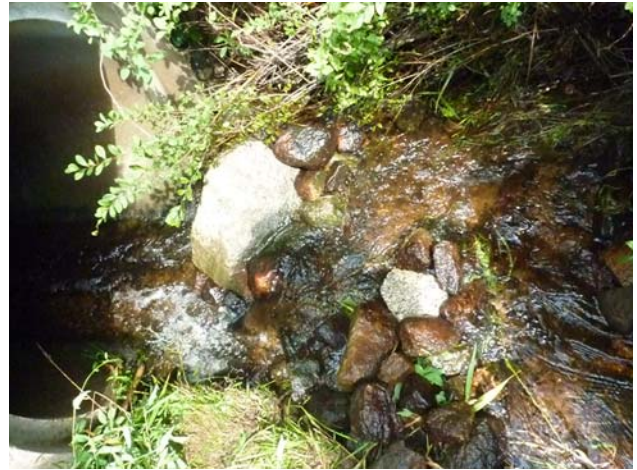
Figure 10: BLO011 Inflow post-restoration (b)

to rest, after swimming the length of the culvert (31.1 metres), and before swimming up the remainder of the stream, which has a natural slope of 25.0%. Eliminating this barrier resulted in an upstream habitat gain of over 1.5 kilometres (Figure 10).

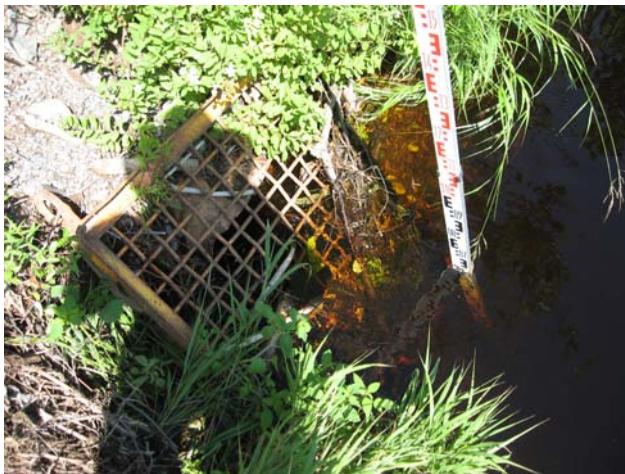
Figure 11: JTM001 Inflow with debris cage

The debris cage located at the inflow side of the culvert was clogged with debris, therefore creating a barrier to fish passage (Figure 11). As a means of restoration, the debris cage and debris (branches and leaves) were removed. Water and fish can now move freely through the culvert, resulting in an upstream habitat gain of approximately 570 metres (Figure 12).

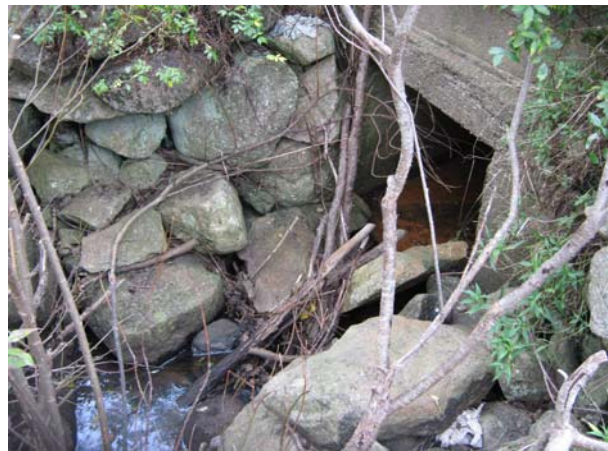
This unknown brook is located in Paradise, Nova Scotia. The brook is approximately 1.5 kilometres in length, and runs into the Annapolis River near Leonard Brook. This brook has only one culvert (LE0003), found where the brook intersects Highway 1. Large rocks from the headwall had fallen in front of the culvert inflow, creating a barrier to fish passage (Figures 13 and 14).

Figure 14: LE0003 Inflow pre-restoration

Equipment used for this remediation included: work gloves, steel-toed boots and a shovel. All rocks that were manageable by hand were removed and placed out of the way, so as not to become a barrier later on. The removal of these barrier rocks resulted in an upstream habitat gain of approximately 1.1 kilometres (Figure 15).

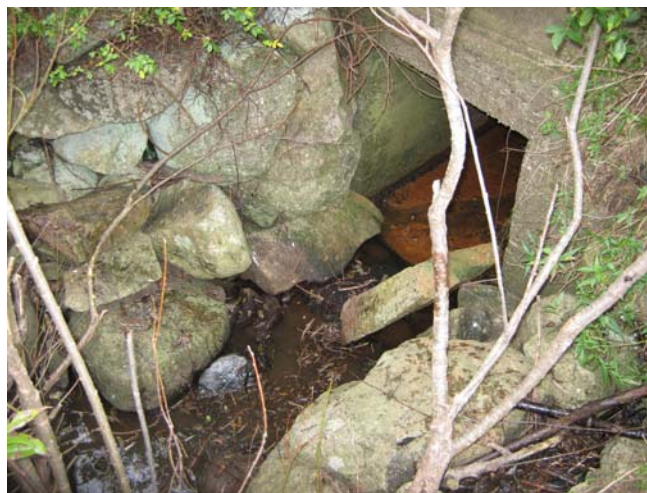
Figure 15: LE0003 Inflow post-restoration

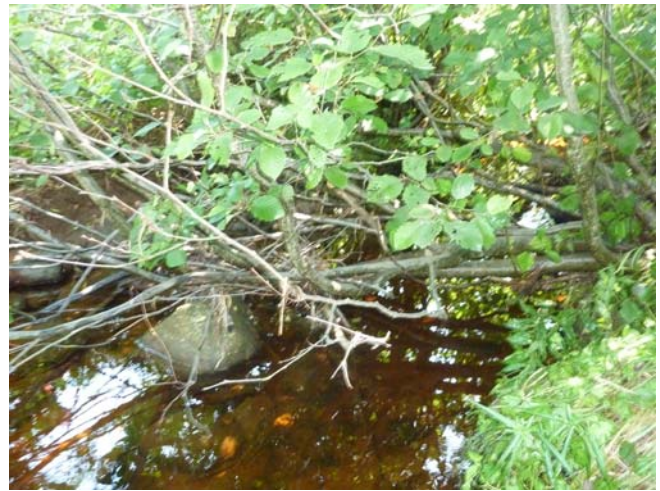
Woodland Brook can be found in Upper Clements, Nova Scotia. The brook is approximately 2.0 kilometres in length and is intersected by the old rail bed and Highway 1. There is a culvert at each intersection; WDL001 is located on Highway 1 and is a high priority culvert (Figure 16). At this location a tree has fallen across the stream, upstream of the culvert (Figure 17). Normally trees that have fallen into

streams tend to have no adverse effects and provide habitat for fish. In this case, over time the tree has collected other tree branches, leaves and sand have built up in front of the tree. This tree has now become a barrier to fish passage.

Figure 17: WDL001 Tree debris pre-restoration

Equipment required to carry out this restoration included: work gloves, handsaw, shovel and steel-toed boots. Remediation efforts involved clearing away the debris that was collecting in front of the tree and to remove some branches from the tree that are causing debris to build up (Figure 18). Removal of this debris resulted in an upstream habitat gain of approximately 1.3 kilometres (Figure 19).

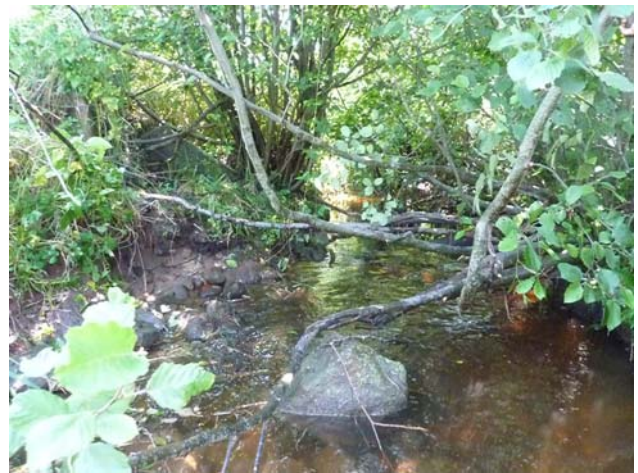
Figure 19: WDL001 Post-restoration

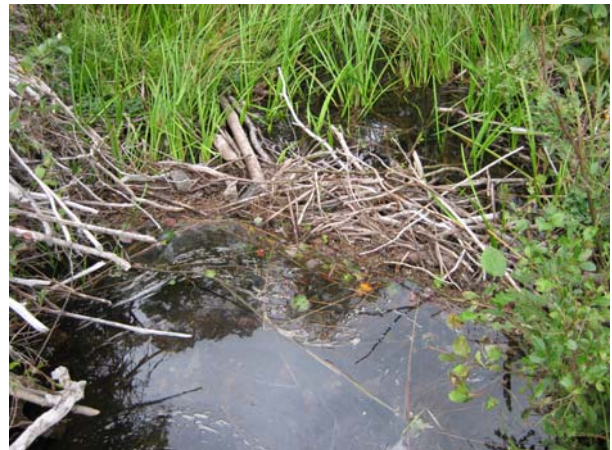
The culvert named LAR002 was properly installed and is functioning although a beaver at one point in time made a dam upstream of the culvert (Figure 21). This beaver dam is old and does not appear to be currently in use. This was determined based on the condition of the branches used to build the dam. These branches are not fresh and have been subjected to decay. There is also evidence that other beaver dams have been removed from this same location in the past. The current beaver dam is a barrier to fish passage, with water flowing over the top of a small section of the dam (Figure 22).

Figure 22: LAR002 Upstream beaver dam

Using work gloves, an extendable hook and a shovel, the beaver dam was dismantled and the branches moved to the side of the stream. With the beaver dam removed, fish now have access to this brook and thus Jerry Lake (Figure 23).

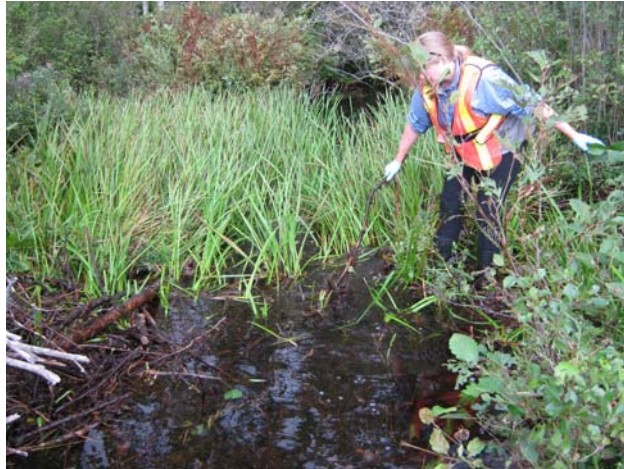
Figure 23: LAR002 Upstream, post-restoration

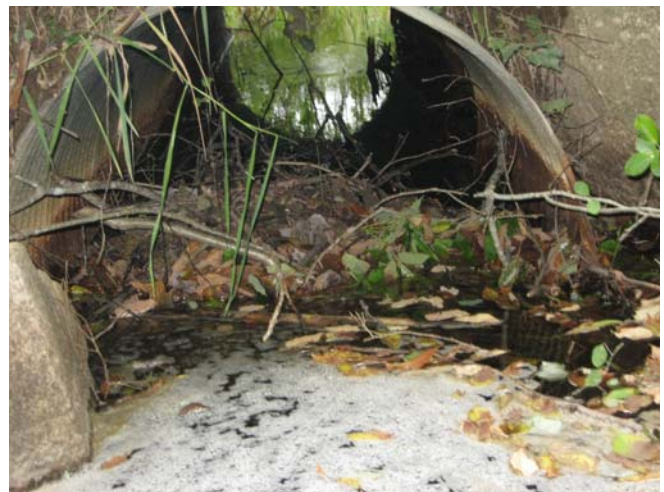
The culvert identified as LAR003 was also properly installed (Figure 24); it has become a barrier to fish passage due to debris that has built-up at the inflow. Debris consisted of several large tree branches and leaves (Figure 25).

Figure 25: LAR003 Inflow pre-restoration

Using work gloves and an extendable hook, debris was slowly removed from the culvert and relocated higher up on the bank (Figure 26). Once the debris was removed a small fish was observed swimming through the culvert.

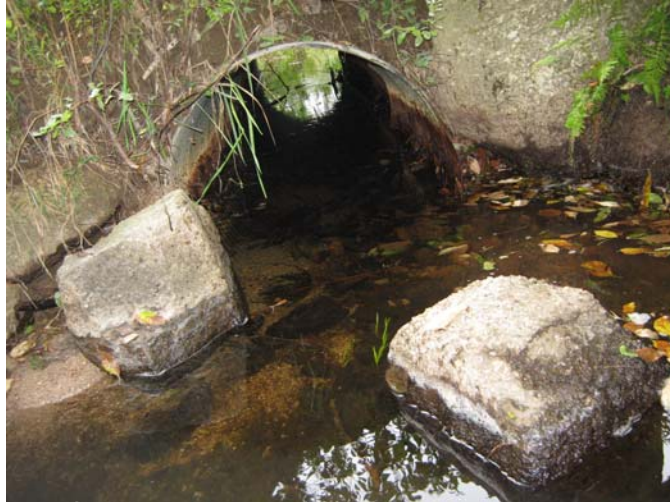
Figure 26: LAR003 Inflow post-restoration

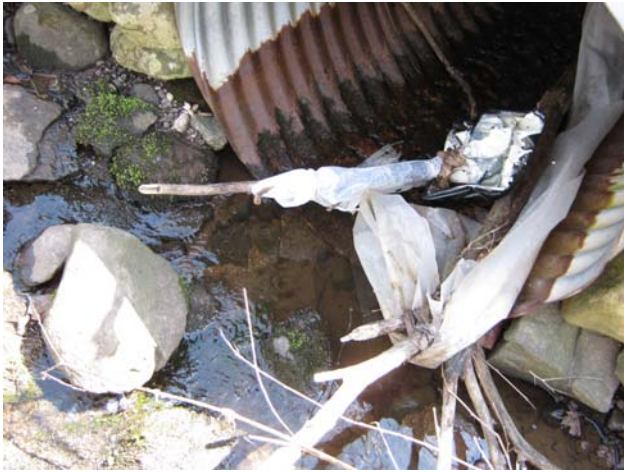
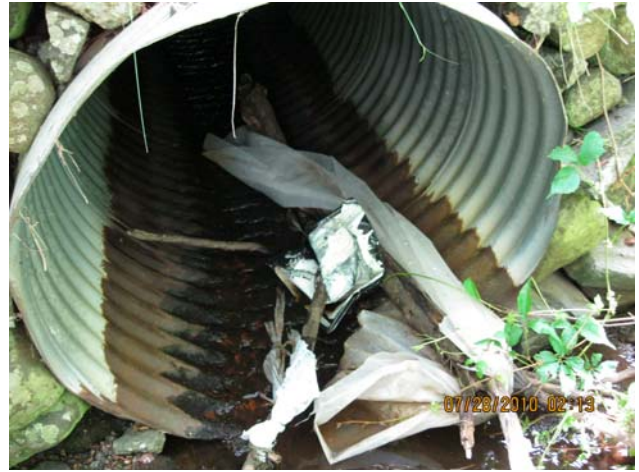
The culvert identified as TR0012 is located on Riverview Lane. Garbage (large sheets of plastics, containers, paint cans, etc.) was found at the inflow of this culvert and throughout the downstream area (Figures 28 and 28).

Figure 28: TR0012 Inflow pre-restoration (a)

Figure 29: TR0012 Inflow pre-restoration (b)

Equipment required to carry out this remediation entailed rubber gloves, garbage bags, and masks. The garbage was picked up and placed in a garbage bag, which was later disposed of properly (Figures 30, 31 and 32). Removing the garbage from this section of brook provided fish with an additional 250 metres of upstream habitat (Figure 33).

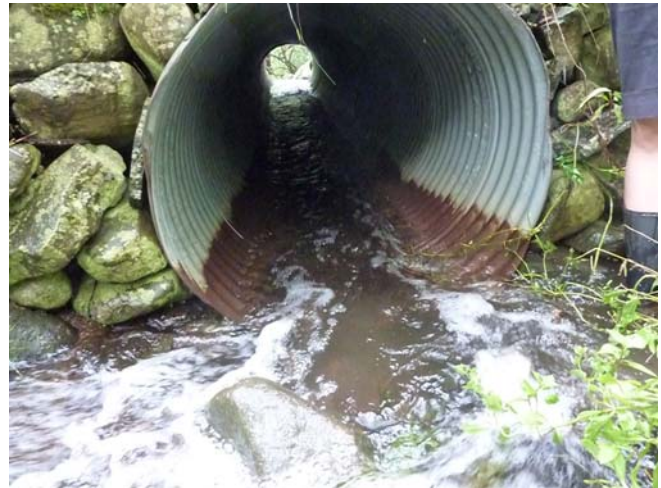
Figure 33: TR0012 Inflow post-restoration

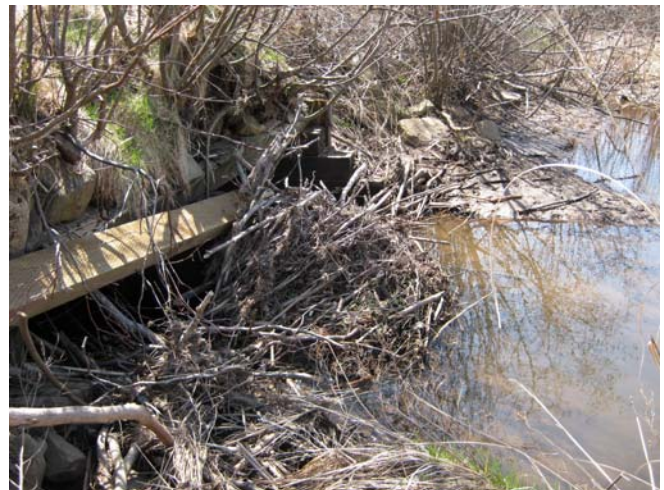
The culvert identified as TR0005, is a large wooden double-mitered box culvert, located on Highway 1 (Figure 34). A very large beaver dam was obstructing the inflow side of this culvert (Figure 35). Based on the conditions of the beaver dam (eroding away) it was concluded that the beaver dam was no longer in use. There was also evidence that this beaver dam had been there for a substantial period of time. The streambed is loaded with fine sand and there was a significant build up of this sand upstream of the beaver dam. So much so that there was nearly a metre drop downstream of the beaver dam (Figures 36 and 37).

Figure 35: TR0005 Inflow with beaver dam

Equipment used to remove the beaver dam included: safety rope (due to high velocity water), work gloves, waders, shovel, extendable hook and steel-toed boots. The removal process was broken into two days. The first day was used to remove the top half of the dam and the second day to remove the bottom half. It took five CARP staff one and a half hours to remove the top half of the dam.

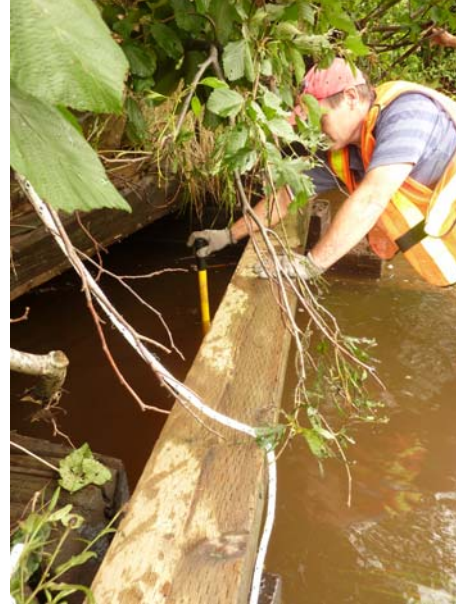
Figure 37: CARP staff indicating the drop behind the beaver dam

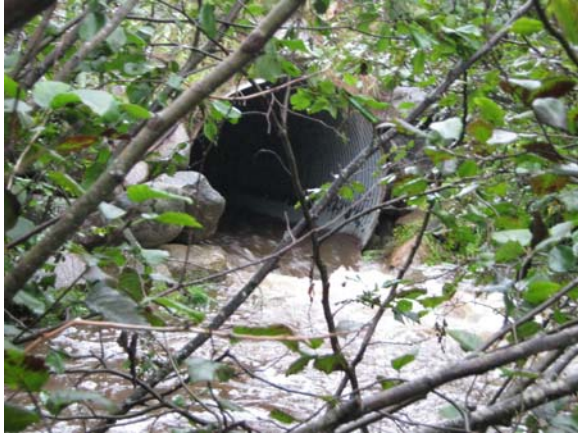
As Table 6 indicates, the culvert is significantly altering the velocity of the water as it travels along the stream. Velocity measurements at the outflow of the culvert are nearly double what they are coming into the culvert. It should also be noted that during the high flow event a velocity reading was taken downstream approximately one metre past the end of the outflow pool and found to be roughly 1.4 m/s, indicating that a vast majority of the energy generated through the culvert dissipates in the outflow pool.

Coupled with the extreme velocity of the water are outflow drops present with both culverts (Figure 40). During low flow conditions culvert #1 displays an outflow drop of 8 cm and culvert #2 an outflow drop of 10 cm (Figure 41).

Figure 40: TRO010 Outflow of culvert #2 at high flow

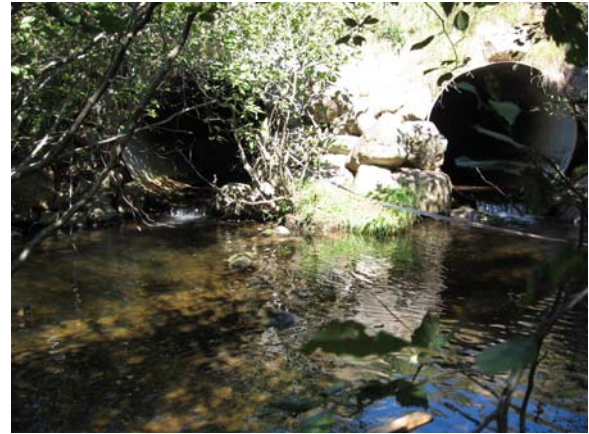
Figure 41: TRO010 Outflow image taken during low flow

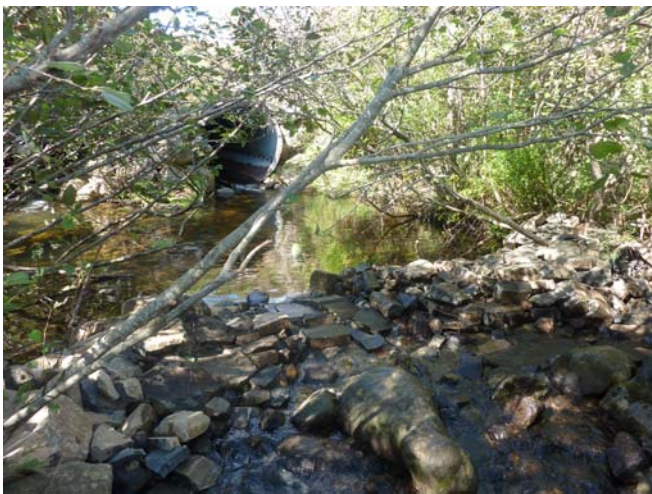
The rock weir will not function right away (Figure 45); it will take time for the interstitial spaces between the rocks to fill in (Figure 46).

Figure 45: Rock weir following its installation

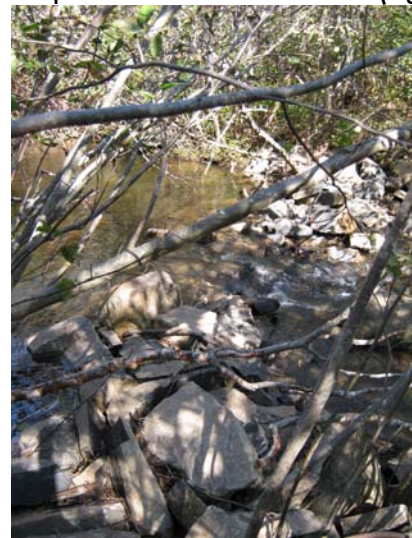
Figure 46: Rock weir functioning 2 weeks post-installation

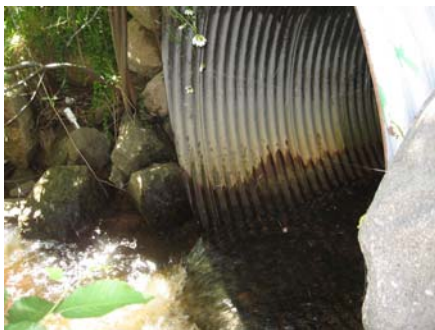
Figure 49: Culvert #1 at low flow

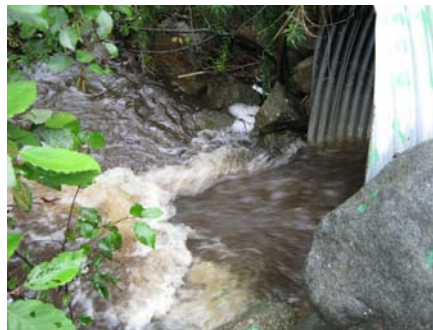
Figure 50: Culvert #1 at high flow

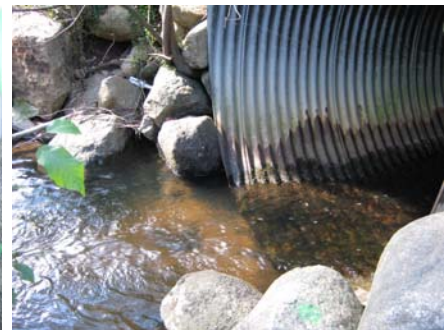
Figure 51: Culvert #1 after tailwater Control

The heavy rain event also caused the weir to shift, and stabilize further. The strong water velocities resulted in displaced rocks that were relocated downstream. The structure of the weir will be continually monitored to ensure that it remains intact, more so after fall high flows and spring freshet.

Four weeks post installation the rock weir was still intact and functioning properly. While the velocity of the water coming through the culvert has been reduced, it has not been reduced enough. Currently only Brook trout (*Salvelinus fontinalis*) 15 cm or larger will easily be able to swim the length of the culvert, Brook trout any smaller will have difficulty given their prolonged swim speed (see Table 7). It is recommended that future remediation of this culvert be to backwater the culvert at least half of its length. To accomplish this, the rock weir will need to be built higher and a second rock weir installed further downstream. Another option is to install baffles in both culverts.
