# Broken Brooks: Culvert Assessments in the Annapolis River Watershed

Kyle Hicks and Denise Sullivan  
Clean Annapolis River Project  
April 2008

**Broken Brooks:  
Culvert Assessments in the Annapolis River Watershed**

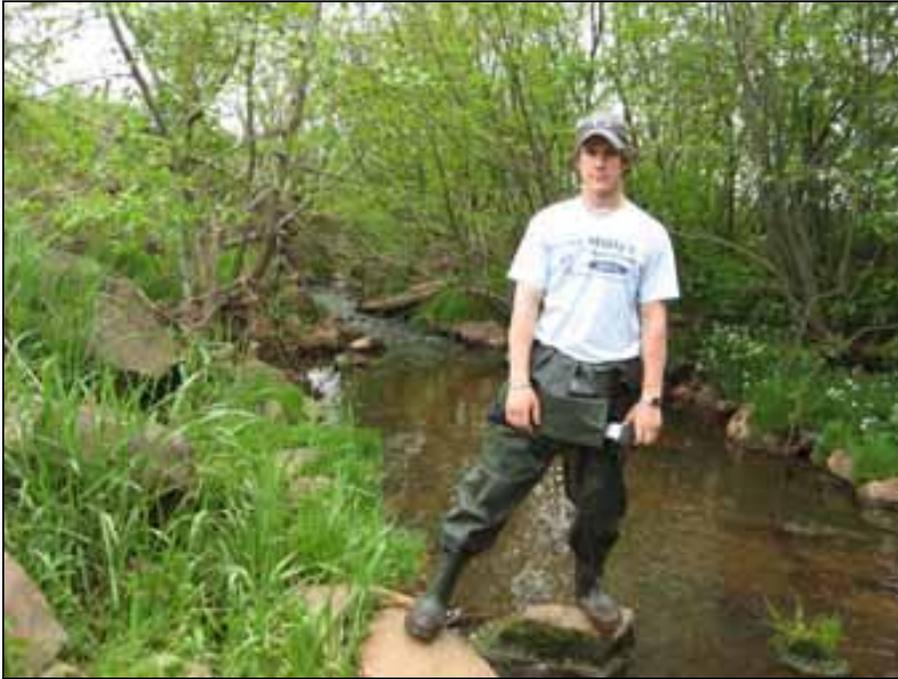
**Figure F1: Downstream view from culvert, Patterson's Brook (PT03)**

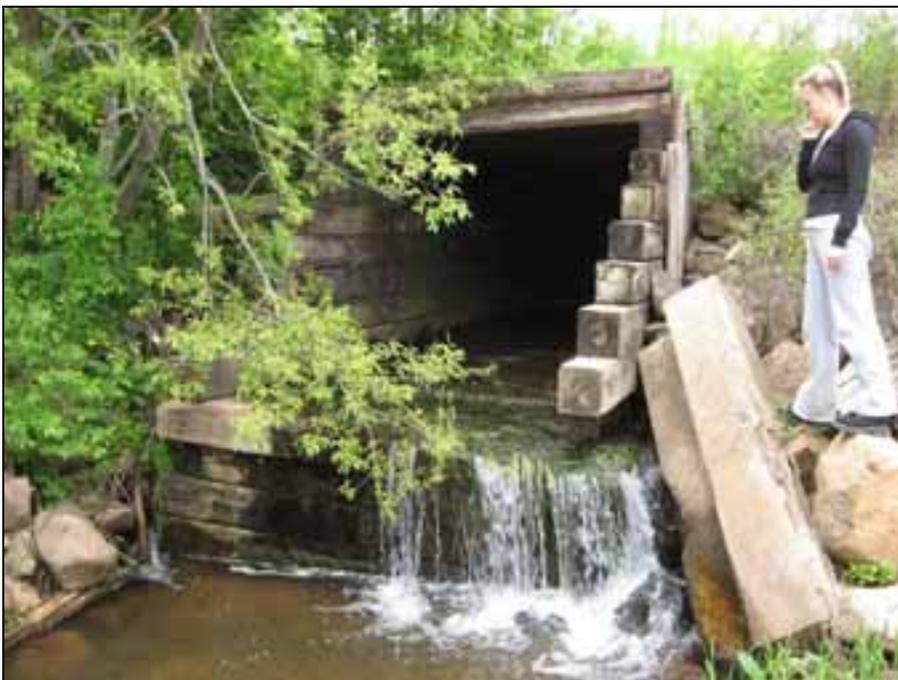
**Figure F2: Outlet view from downstream, Patterson's Brook (PT03)**

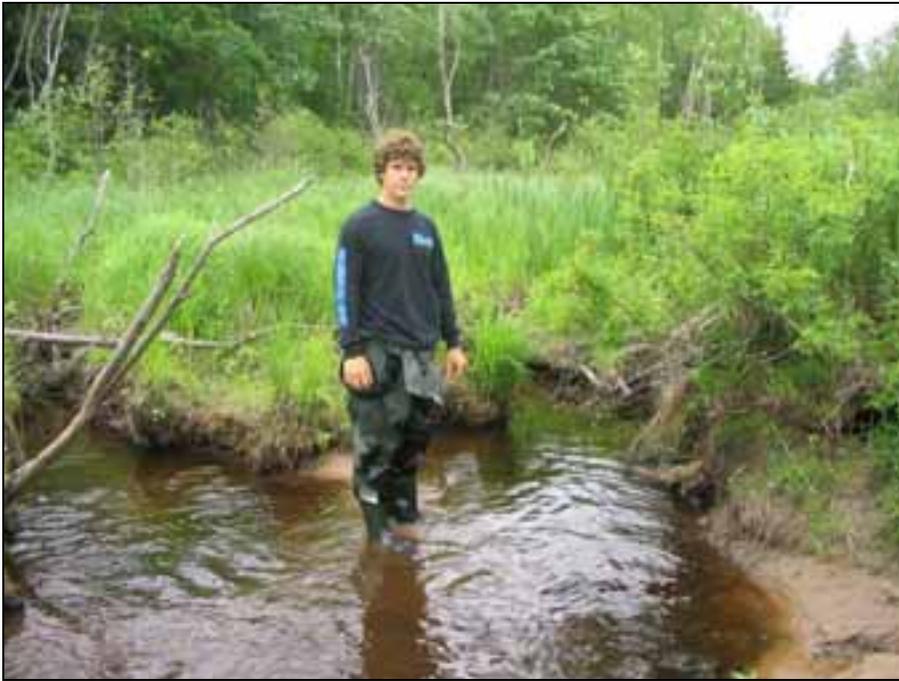
**Figure F3: Downstream view from culvert, McEwan Brook (MW02)**

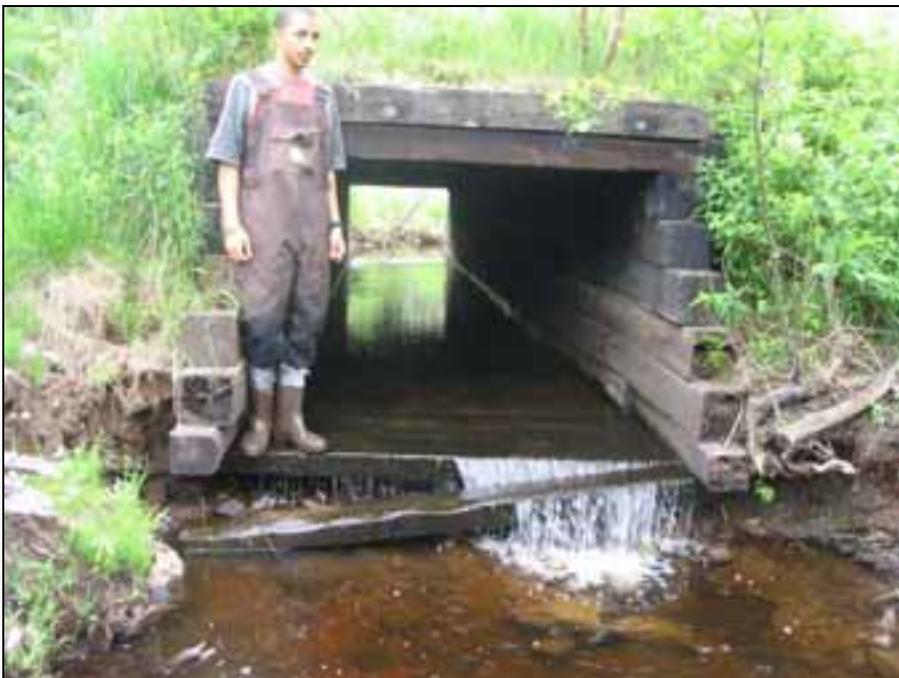
**Figure F4: Outlet view from downstream, McEwan Brook (MW02)**

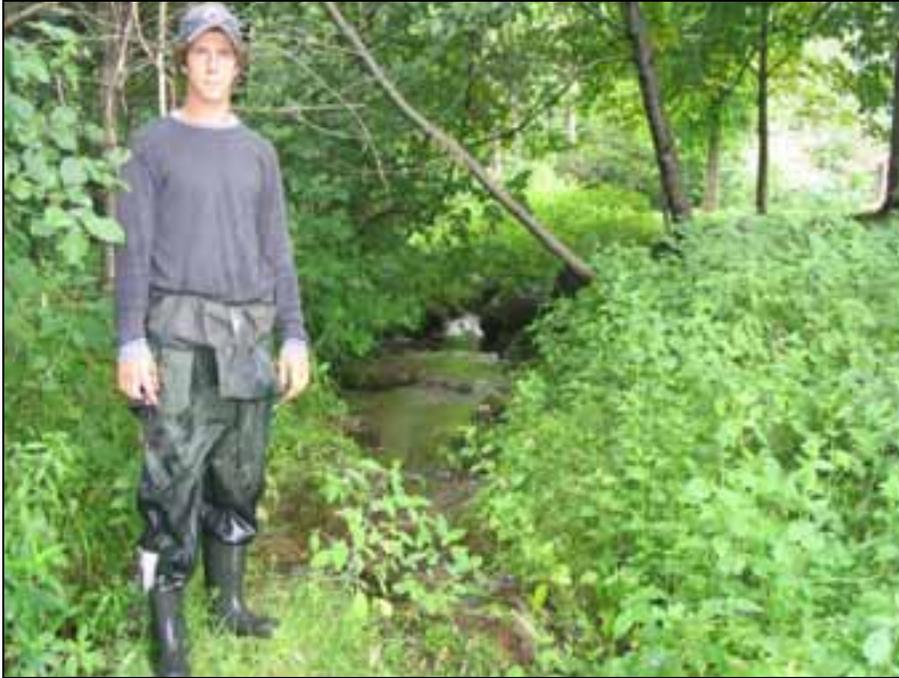
**Figure F5: Upstream view from culvert, Fash Brook (FB02)**

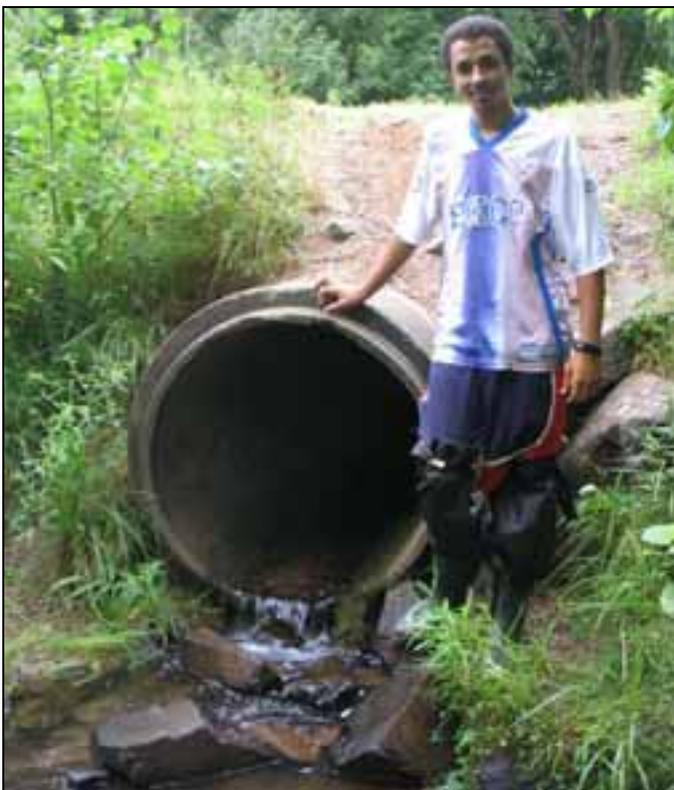
**Figure F6: Outlet view from downstream, Fash Brook (FB02)**

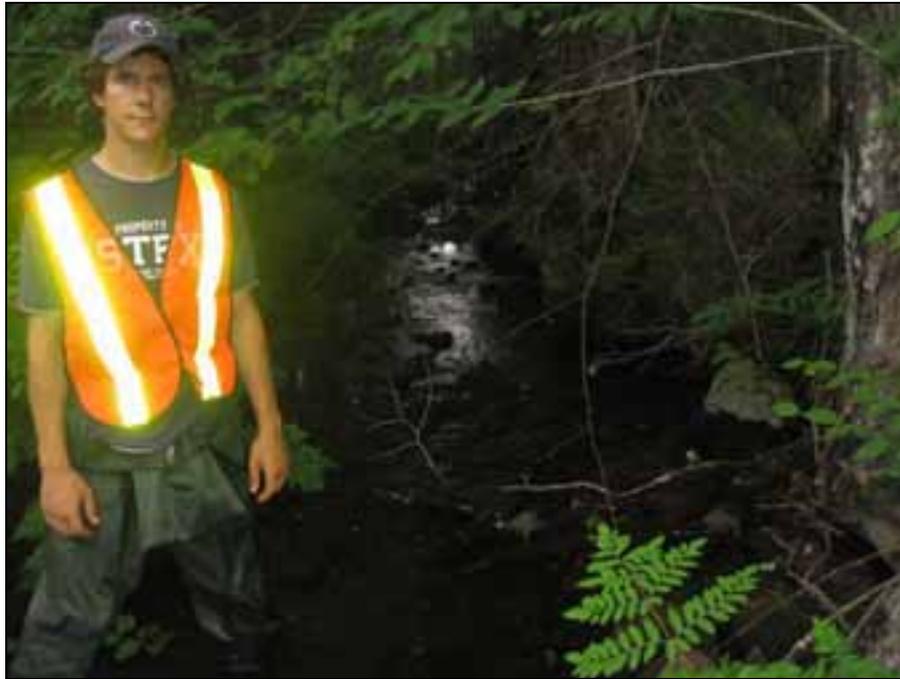
Figure F7: Downstream view from culvert, Roundhill River (RH06)

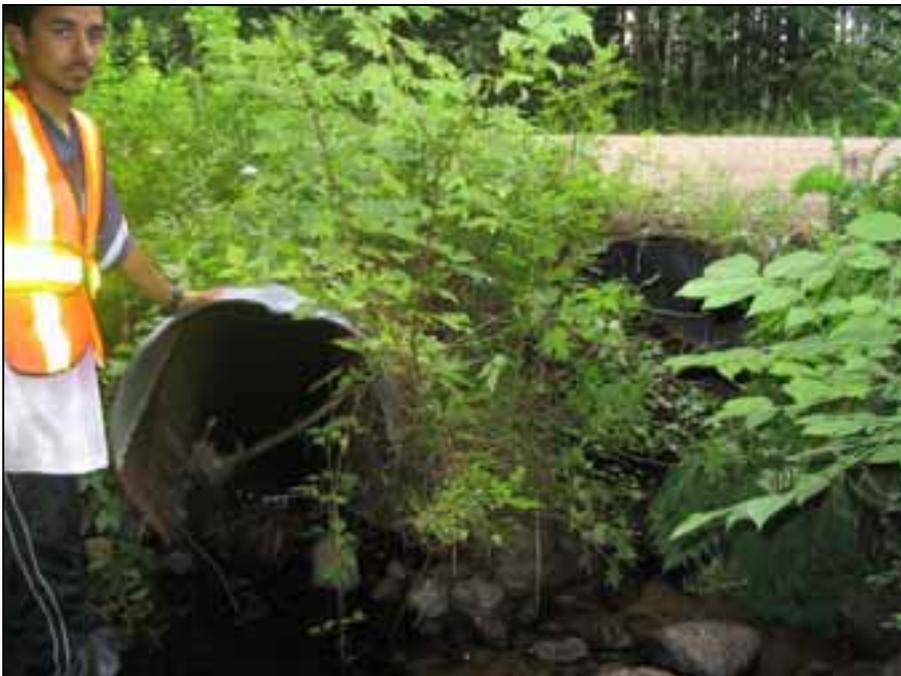
Figure F8: Outlet view from downstream, Roundhill River (RH06)

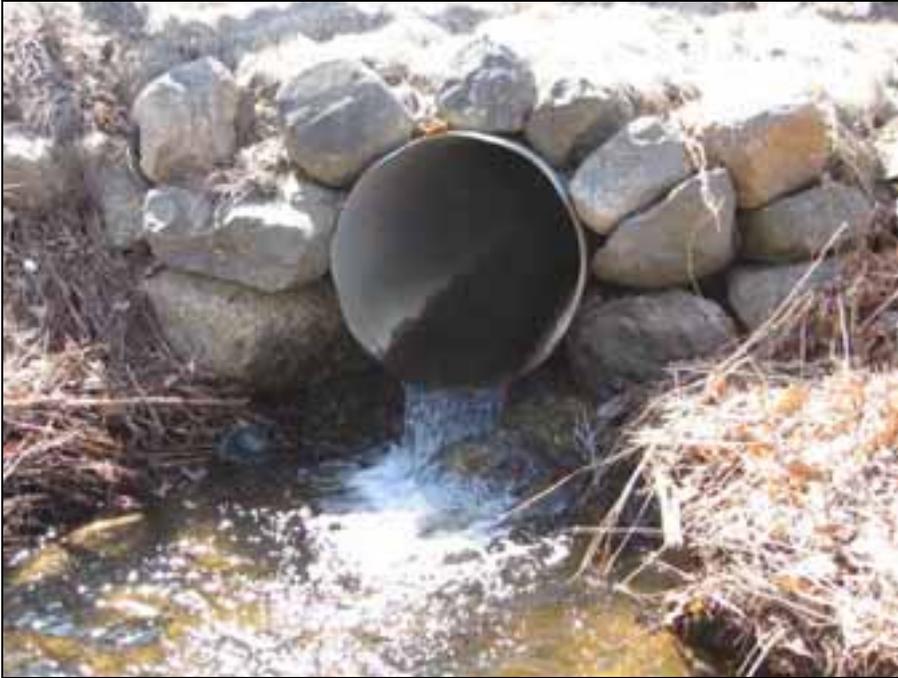
**Figure F9: Outlet view from downstream, Fales River (FR01)**

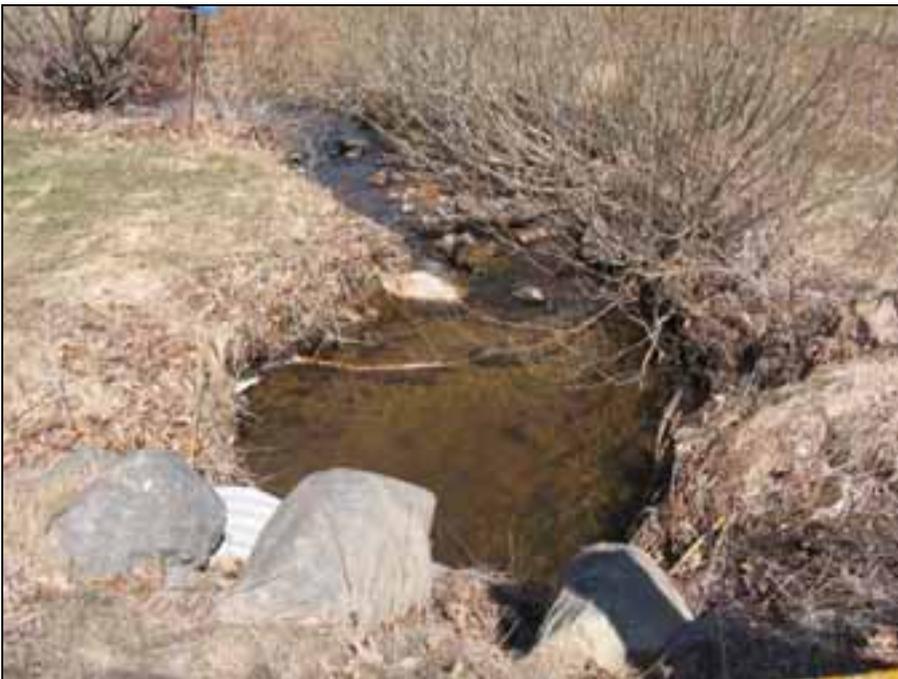
**Figure F10: Downstream view from culvert, Fales River (FR01)**

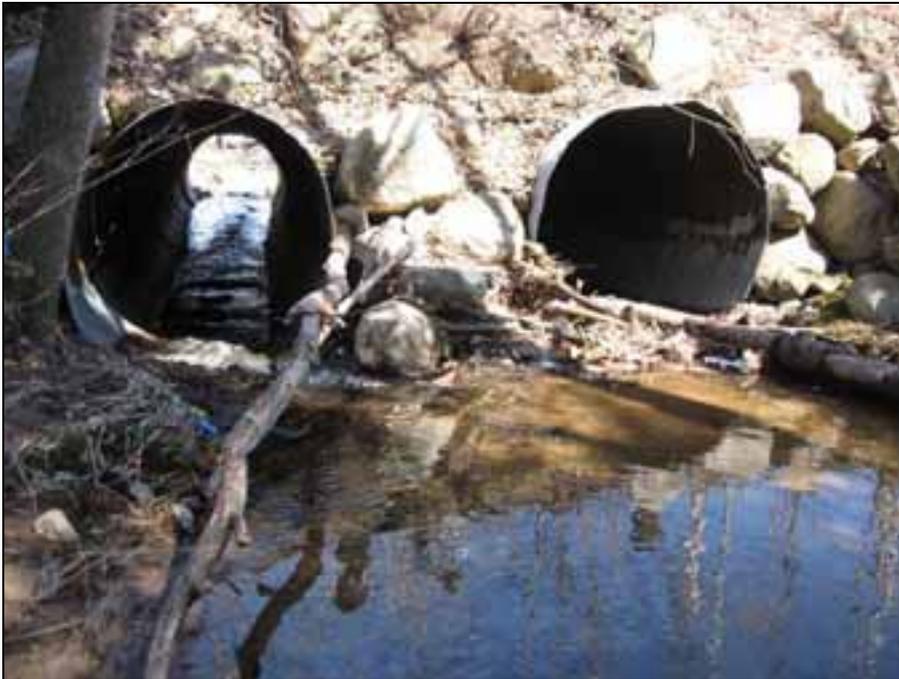
**Figure F11: Inlet view from upstream, Fales River (FR02)**

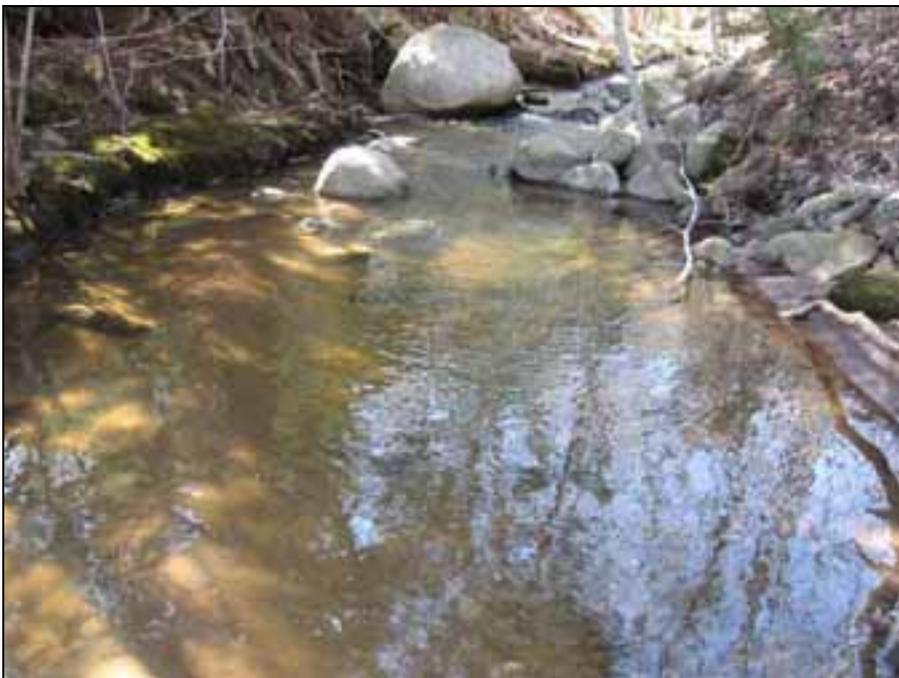
**Figure F12: Upstream view from culvert, Fales River (FR02)**

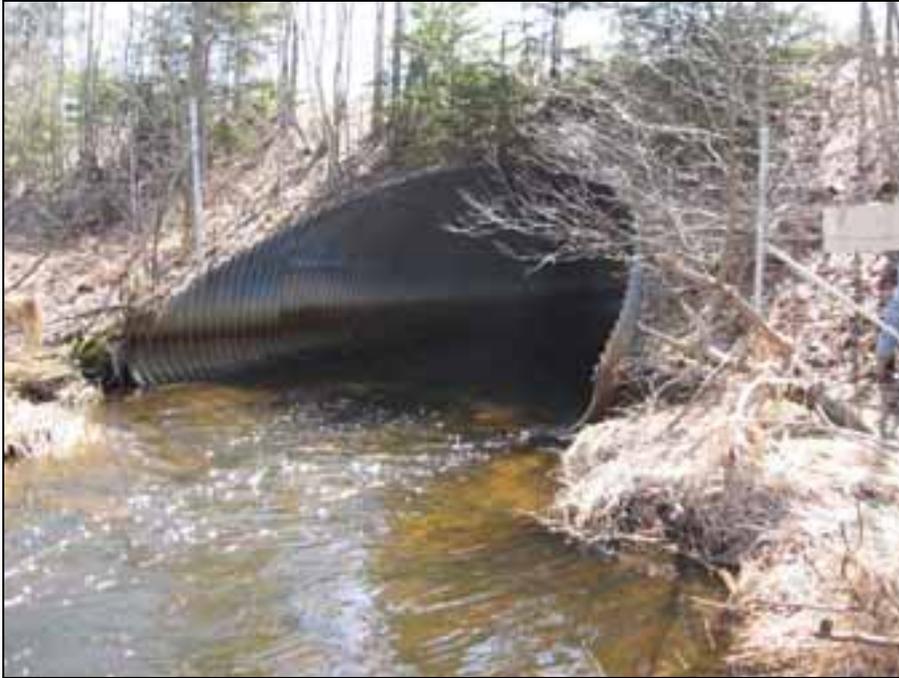
**Figure F 13: Outlet view from downstream, Zekes Brook (ZB01) (Photo taken during spring high water flows)**

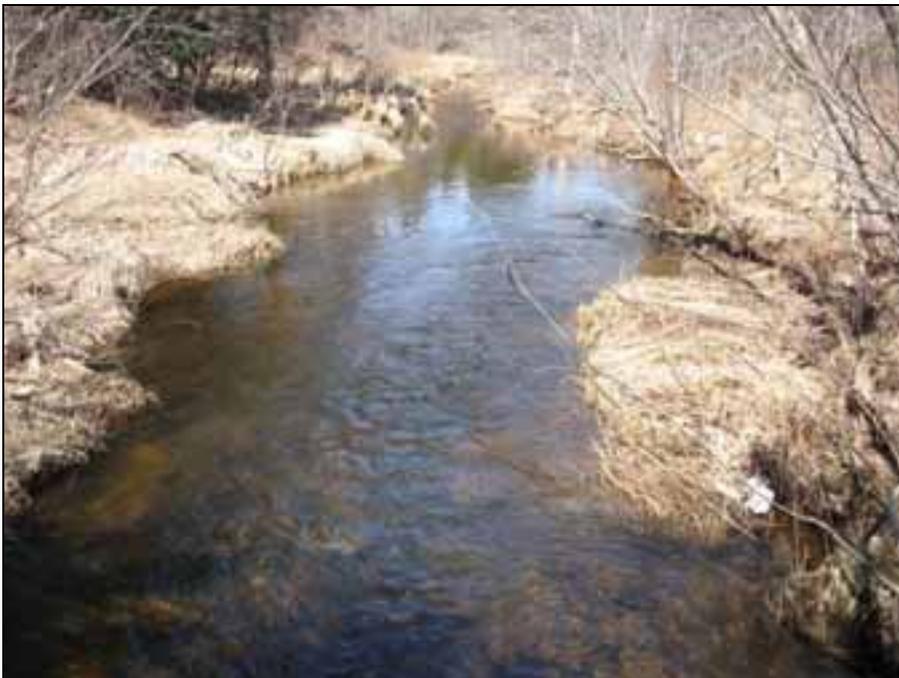
**Figure F14: Downstream view from culvert, Zekes Brook (ZB01) (Photo taken during spring high water flows)**

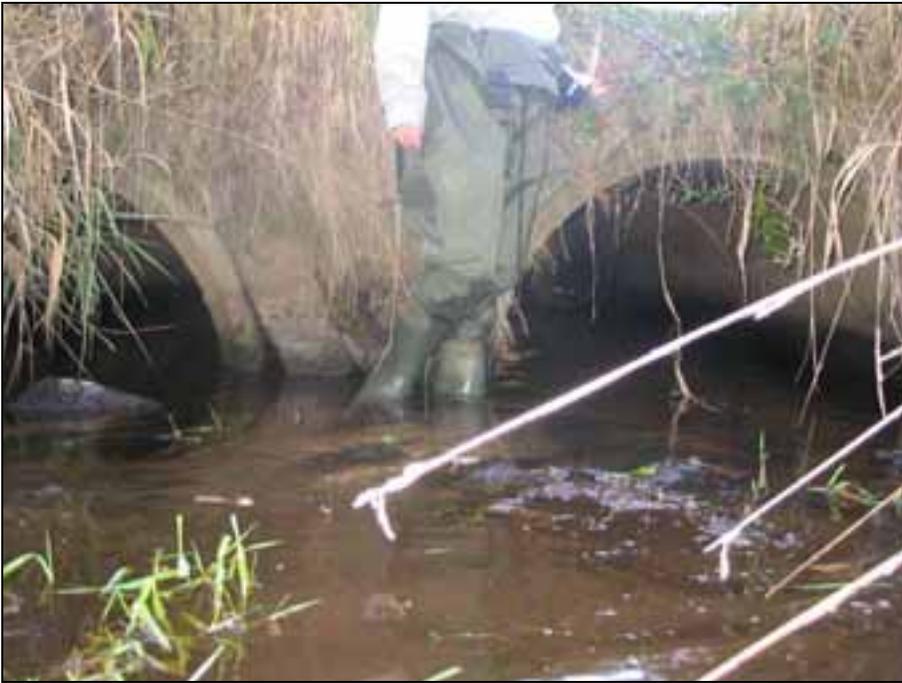
**Figure F15: Inlet view from upstream, Bear Brook (BB02)**

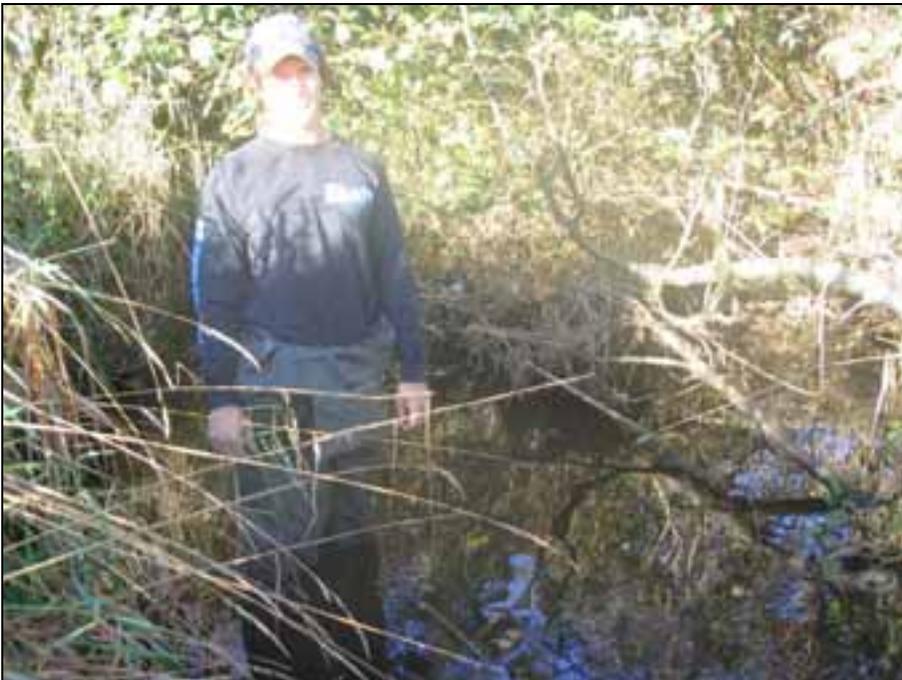
**Figure F16: Upstream view from culvert, Bear Brook (BB02)**

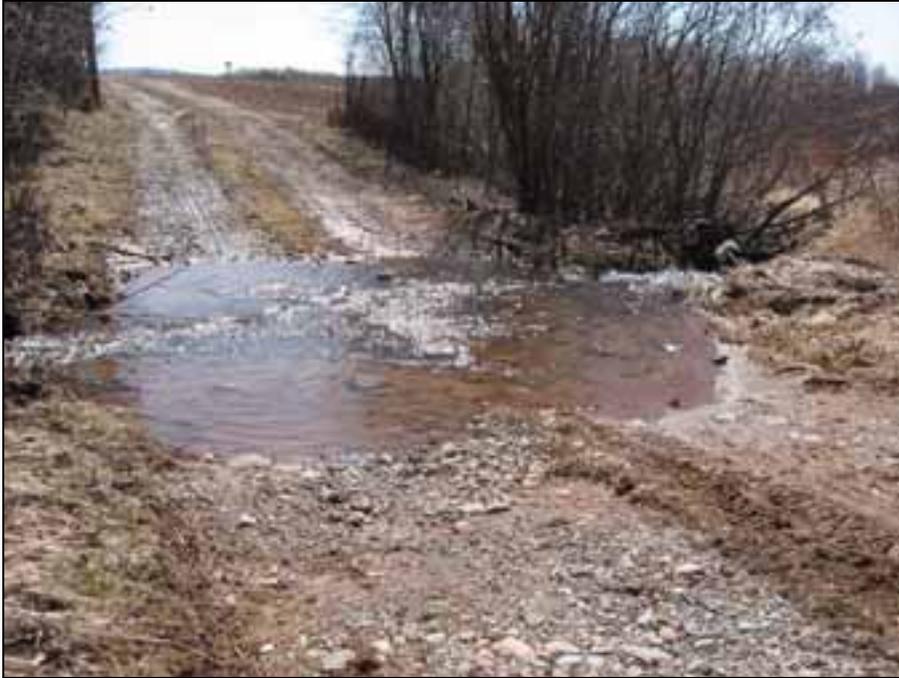
**Figure F15: Downstream view, Patterson Brook (PT01)**

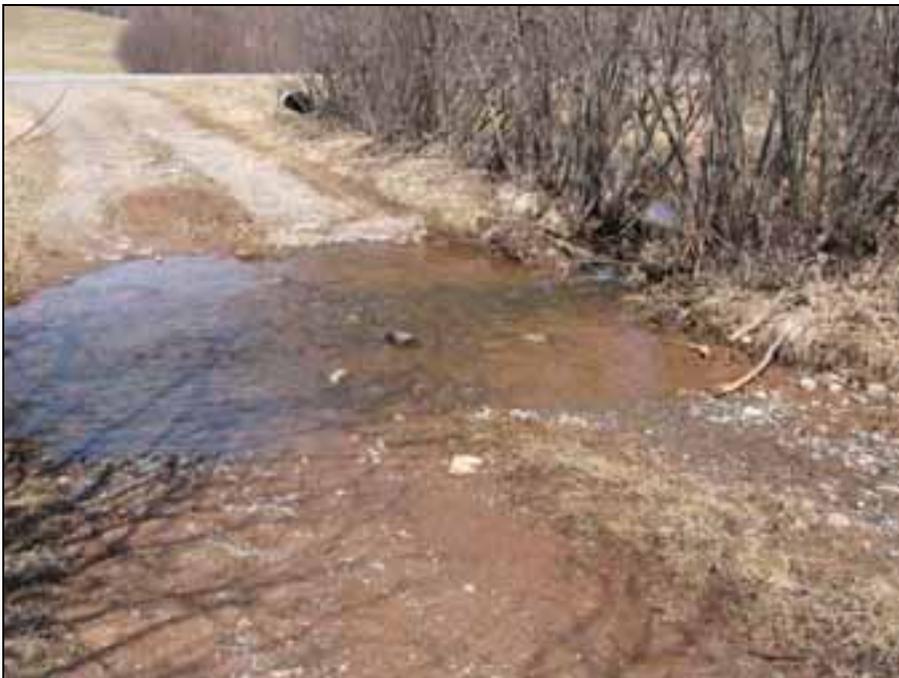
**Figure F16: Upstream view, Patterson Brook (PT01)**

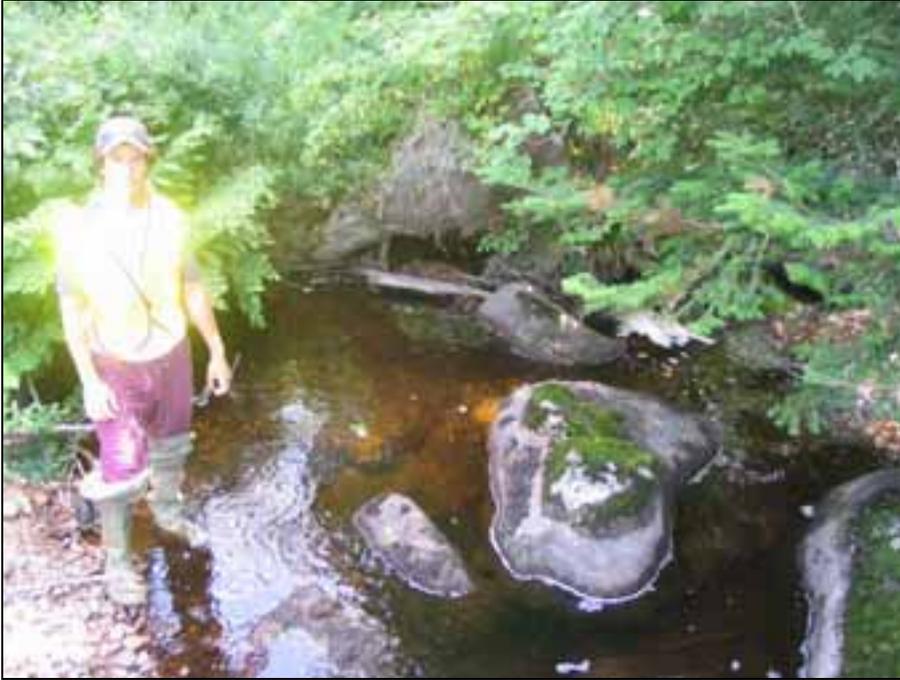
**Figure F17: Downstream view from culvert, Round Hill River (RH04)**

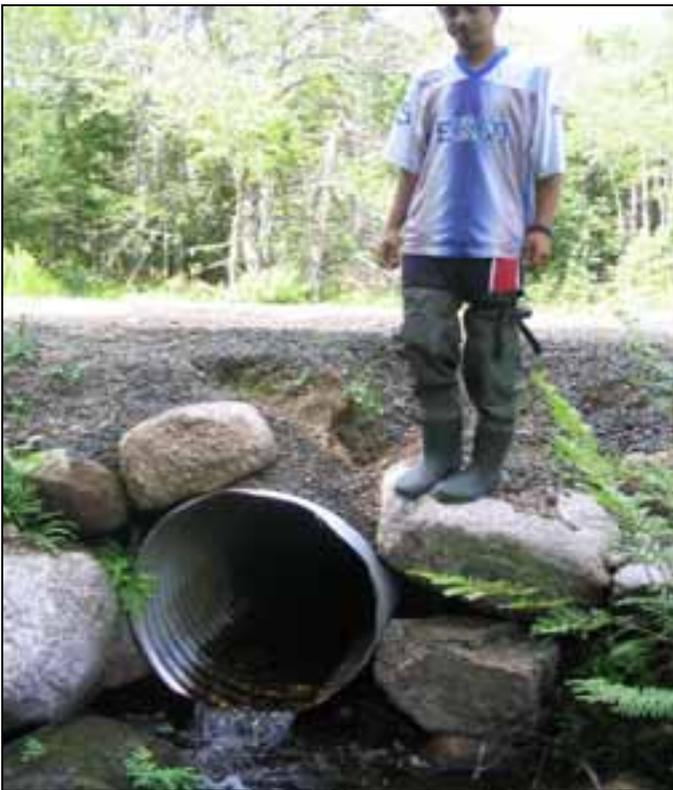
**Figure F18: Outlet view from downstream, Round Hill River (RH04)**
