Broken Brooks

Repairing Past Wrongs

A Clean Annapolis River Project Initiative
By Katie Taylor, Ecological Restoration Technician
December 2010

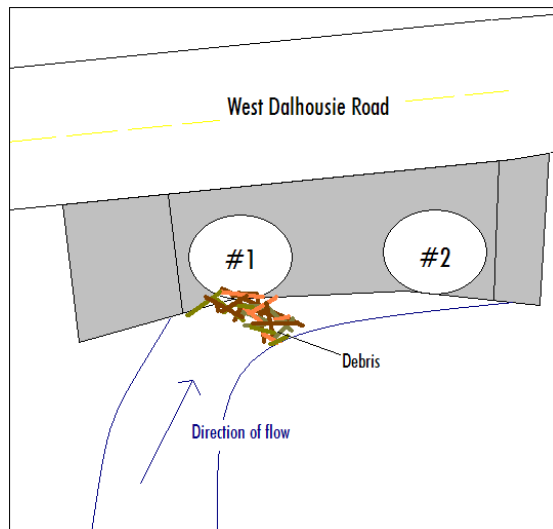
Figure 4: ALL022 Inflow

Allains River runs into the Annapolis Basin, the outflow runs along Fort Anne National Historic Site in Annapolis Royal. The river system is over ten kilometres long with multiple stream branches, anywhere from 400 to 1,600 metres in length. Allains River intersects six roadways: Route 8, Highway 101, Highway 1, Dugway Road, Clementsvalle Road, and West Dalhousie Road. There also exist two bridges and at least 14 culverts. All 14 culverts located on Allains River were assessed and four were deemed barriers to fish passage; one high priority culvert and three medium priority culverts. ALL022 that intersects West Dalhousie Road was determined to be a medium priority culvert (Figure 4). There are two steel culverts encompassed in a cement wingwall. Branches, leaves and sand had built up in front of the first culvert, which in turn is also obstructing fish passage to the second culvert (Figure 5). The debris was removed using a shovel, and placed further in on the bank so as not to wash back into the stream. With the debris cleared, water is now flowing freely through both culverts and over 650m of upstream habitat was gained (Figure 6).

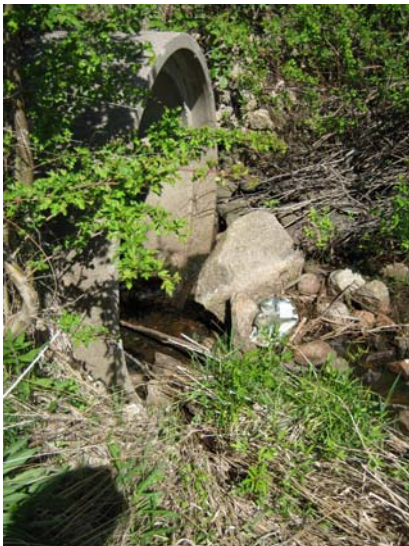
Figure 7: BLO011 Inflow

BLO011 is located on an unnamed stream, which is in the vicinity of Bloody Creek Brook. This un-named brook is just over three kilometres in length. Four roads intersect the brook: the old rail bed, Brickyard Road, Highway 201 and Highway 101. There are four culverts located on this brook; BLO011, which is located on Highway 101, is a high priority culvert and the only barrier culvert on this stream. A combination of rocks from the headwall, and rocks that have been carried downstream, have collected at the inflow side of the culvert causing a barrier to fish passage (Figure 7). It is hard to see from the image below, but the rocks located in front of the culvert are creating a drop as the water falls into the culvert. For a fish swimming up the culvert, it would be difficult to make the jump over the rocks and into the upstream due to the velocity of the upstream water and the lack of a pool at the base of the fallen rocks (Figure 8).

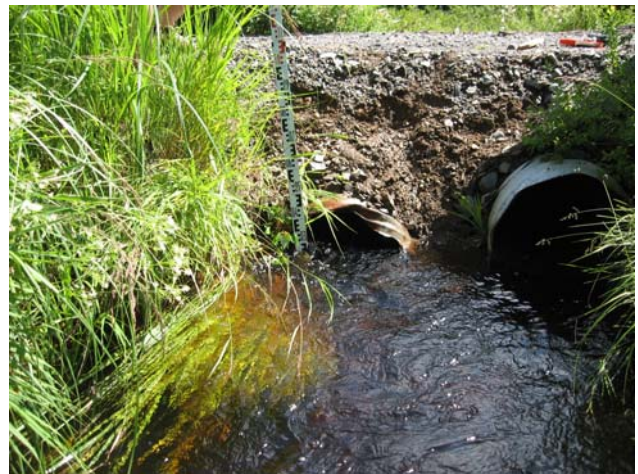
Figure 12: JTM001 Outflow

The debris cage located at the inflow side of the culvert was clogged with debris, therefore creating a barrier to fish passage (Figure 11). As a means of restoration, the debris cage and debris (branches and leaves) were removed. Water and fish can now move freely through the culvert, resulting in an upstream habitat gain of approximately 570 metres (Figure 12).

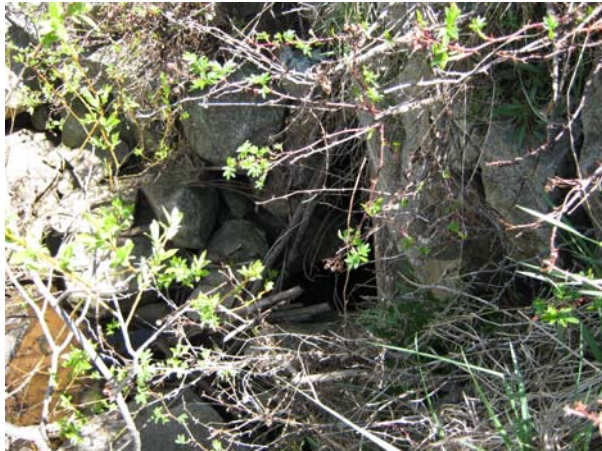
Figure 13: LE0003 Inflow

This unknown brook is located in Paradise, Nova Scotia. The brook is approximately 1.5 kilometres in length, and runs into the Annapolis River near Leonard Brook. This brook has only one culvert (LE0003), found where the brook intersects Highway 1. Large rocks from the headwall had fallen in front of the culvert inflow, creating a barrier to fish passage (Figures 13 and 14).

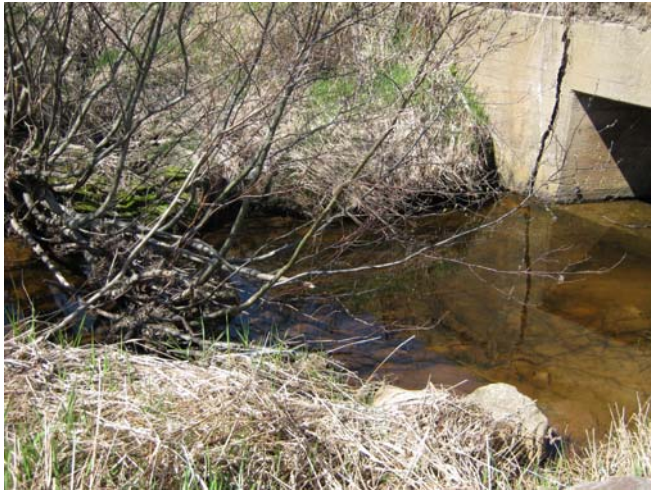
Figure 16: WDL001 Inflow

Woodland Brook can be found in Upper Clements, Nova Scotia. The brook is approximately 2.0 kilometres in length and is intersected by the old rail bed and Highway 1. There is a culvert at each intersection; WDL001 is located on Highway 1 and is a high priority culvert (Figure 16). At this location a tree has fallen across the stream, upstream of the culvert (Figure 17). Normally trees that have fallen into

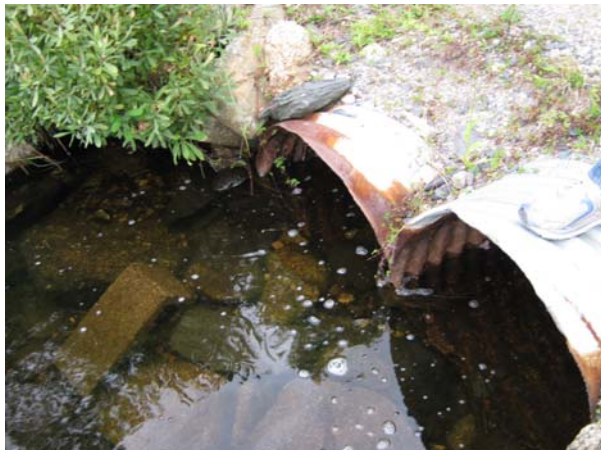
Figure 21: LAR002 Inflow

The culvert named LAR002 was properly installed and is functioning although a beaver at one point in time made a dam upstream of the culvert (Figure 21). This beaver dam is old and does not appear to be currently in use. This was determined based on the condition of the branches used to build the dam. These branches are not fresh and have been subjected to decay. There is also evidence that other beaver dams have been removed from this same location in the past. The current beaver dam is a barrier to fish passage, with water flowing over the top of a small section of the dam (Figure 22).

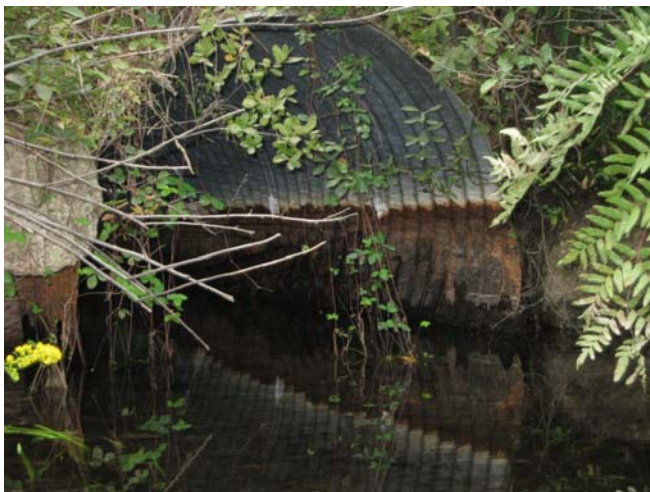
Figure 24: LAR003 Outflow

The culvert identified as LAR003 was also properly installed (Figure 24); it has become a barrier to fish passage due to debris that has built-up at the inflow. Debris consisted of several large tree branches and leaves (Figure 25).

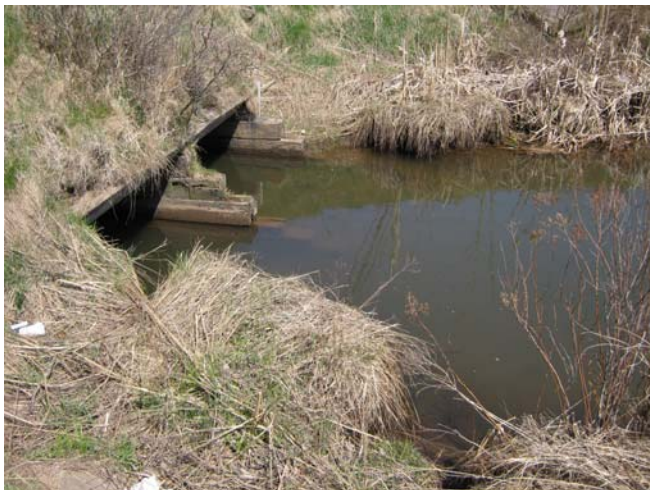
Figure 34: TR0005 Outflow

The culvert identified as TR0005, is a large wooden double-mitered box culvert, located on Highway 1 (Figure 34). A very large beaver dam was obstructing the inflow side of this culvert (Figure 35). Based on the conditions of the beaver dam (eroding away) it was concluded that the beaver dam was no longer in use. There was also evidence that this beaver dam had been there for a substantial period of time. The streambed is loaded with fine sand and there was a significant build up of this sand upstream of the beaver dam. So much so that there was nearly a metre drop downstream of the beaver dam (Figures 36 and 37).

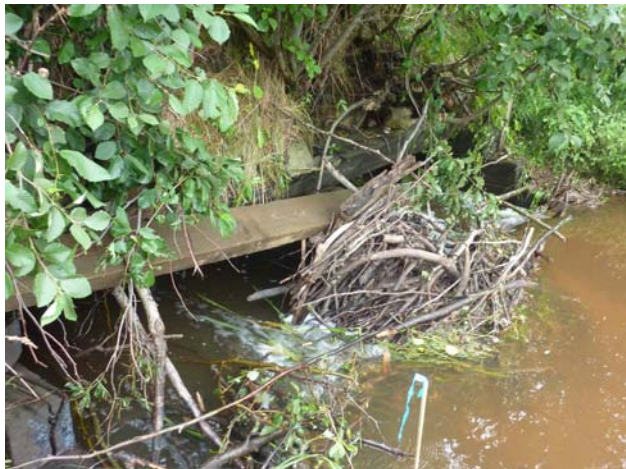
Figure 38: TRO005 pre-restoration

After day one, the stream was left alone for a few days so that the substrate would have time to settle after such a dramatic change (Figure 38). When CARP staff returned a few days later, the significance of the sediment build up was much more evident. The sediment had shifted further into the culvert. It was decided that as opposed to digging into the sediment pile to remove the remaining beaver dam, that it would be left as is to settle out on its own. During the high flow season, the stream will likely reach equilibrium (Figure 39).
