# Broken Brooks: Culvert Assessments in the Annapolis River Watershed

Kyle Hicks and Denise Sullivan  
Clean Annapolis River Project  
April 2008

**Broken Brooks:  
Culvert Assessments in the Annapolis River Watershed**

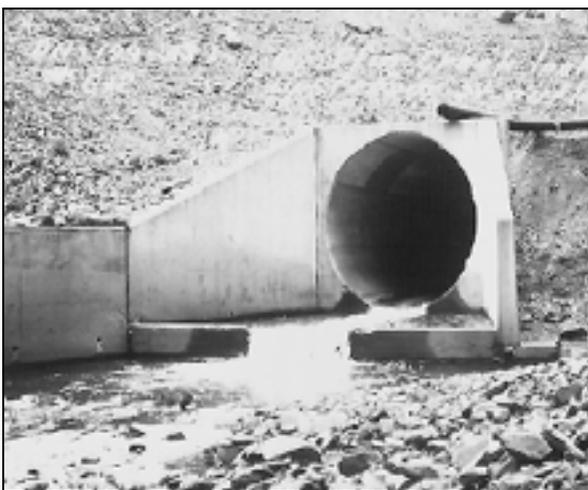
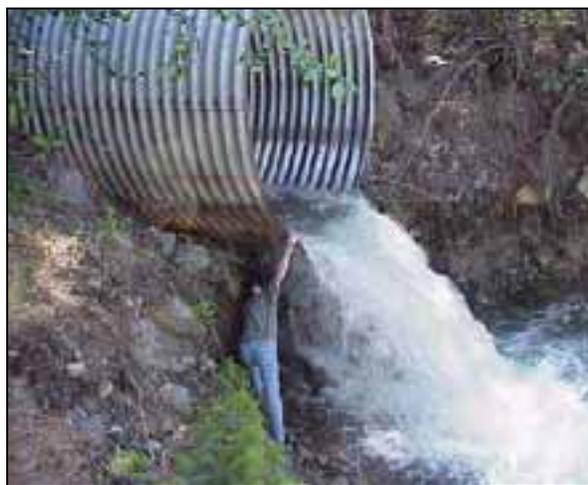
A frequent reason for having to increase water depth is when the geometry of the stream channel or culvert barrel has a large cross sectional area, producing shallow water depths. This condition can be especially prevalent with existing culvert facilities having broad, concrete outlet aprons (Figure 8-1a); and with box culverts or any large diameter culvert, whether new or existing. Placement of a grade control weir can help insure a minimum water depth upstream of the weir. A low flow notch, sized to contain the fish passage low flow, is commonly used to focus the flow pattern and encourage sediment transport through the low flow fish passage condition.

Grade control structures are also used to raise the downstream channel up to the level of the culvert. A common condition requiring this type of remediation is when existing culverts have been undersized, resulting in scour holes at the culvert outlet (Figure 8-1b). The two approaches generally used to correct these elevation differentials are 1) grade control weirs, which use a series of separate structures to produce incremental small drops in the water surface, and 2) roughened channels.

**Figure 8-1. Applications for the use of grade control design include a) sites with concrete outlet aprons and b) perched culverts.**
